JK World Enterprises Inc.

Letter Report #: 102319164COQ-001L1  
Project #: G102319164

### RE: Uniform Load Test Summary

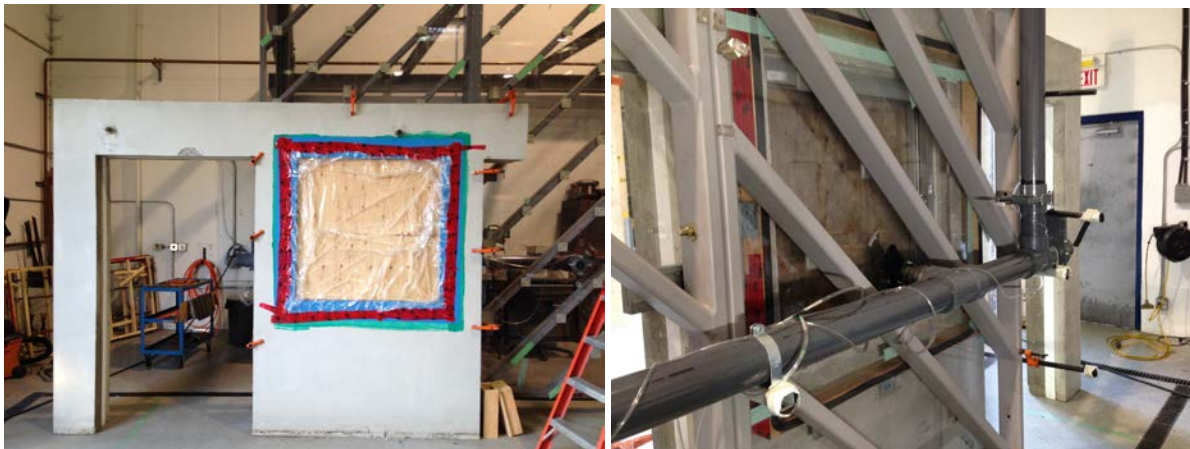
Because no IGU was installed on this window unit, two layers of 3/4" spruce plywood was used over top of the window frame in order to ensure a uniform load across all frame members. Polyethylene film was also used over top afterwards to prevent excess air leakage. A 2x4 frame was installed on the opposite side to isolate the area around the window opening. Below are photos of the tested specimen.

The concrete assembly was made up of 3 layers; 5-5/8" thick concrete, 2-7/8" thick PVC composite material, 3-1/8" thick concrete. The fixed window framing was 40-1/2" x 40-1/2" and was installed within a 42" x 42" opening using 3x fasteners, #10 x 1-1/2" flat head zinc screws, along each member. Fasteners were installed from the window frame members into the PVC composite material identified as "Tigerloc", spaced approximately 2" from the corners and 1x at mid-span.

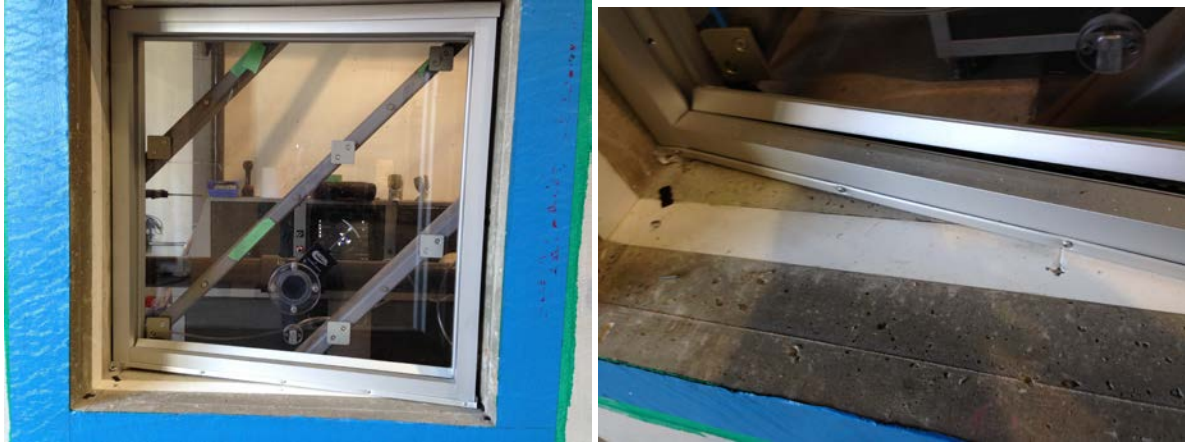
The uniform load test was performed by gradually increasing the pressure until the point of failure. The system had loaded up to 490 psf before the fasteners had sheared.
